Eduardo Anzueto (ANRE-ENRE), Chelsie Werling (ANRE-ENRE)

Problem Statement:

Cypress Lake is a former “borrow pit” located at the junction of I-65 and State Road 11 in southern Indiana near Seymour. Drainage was originally provided by two low water crossings. After a culvert was installed to facilitate site access, farm fields to the south of the lake began to flood more frequently. A good solution to this problem will increase the ability of the lake to drain through its main outlet, reduce alternate channel formation, decrease channel bank erosion, and honor the Indiana Department of Natural Resources’ commitment to habitat preservation.

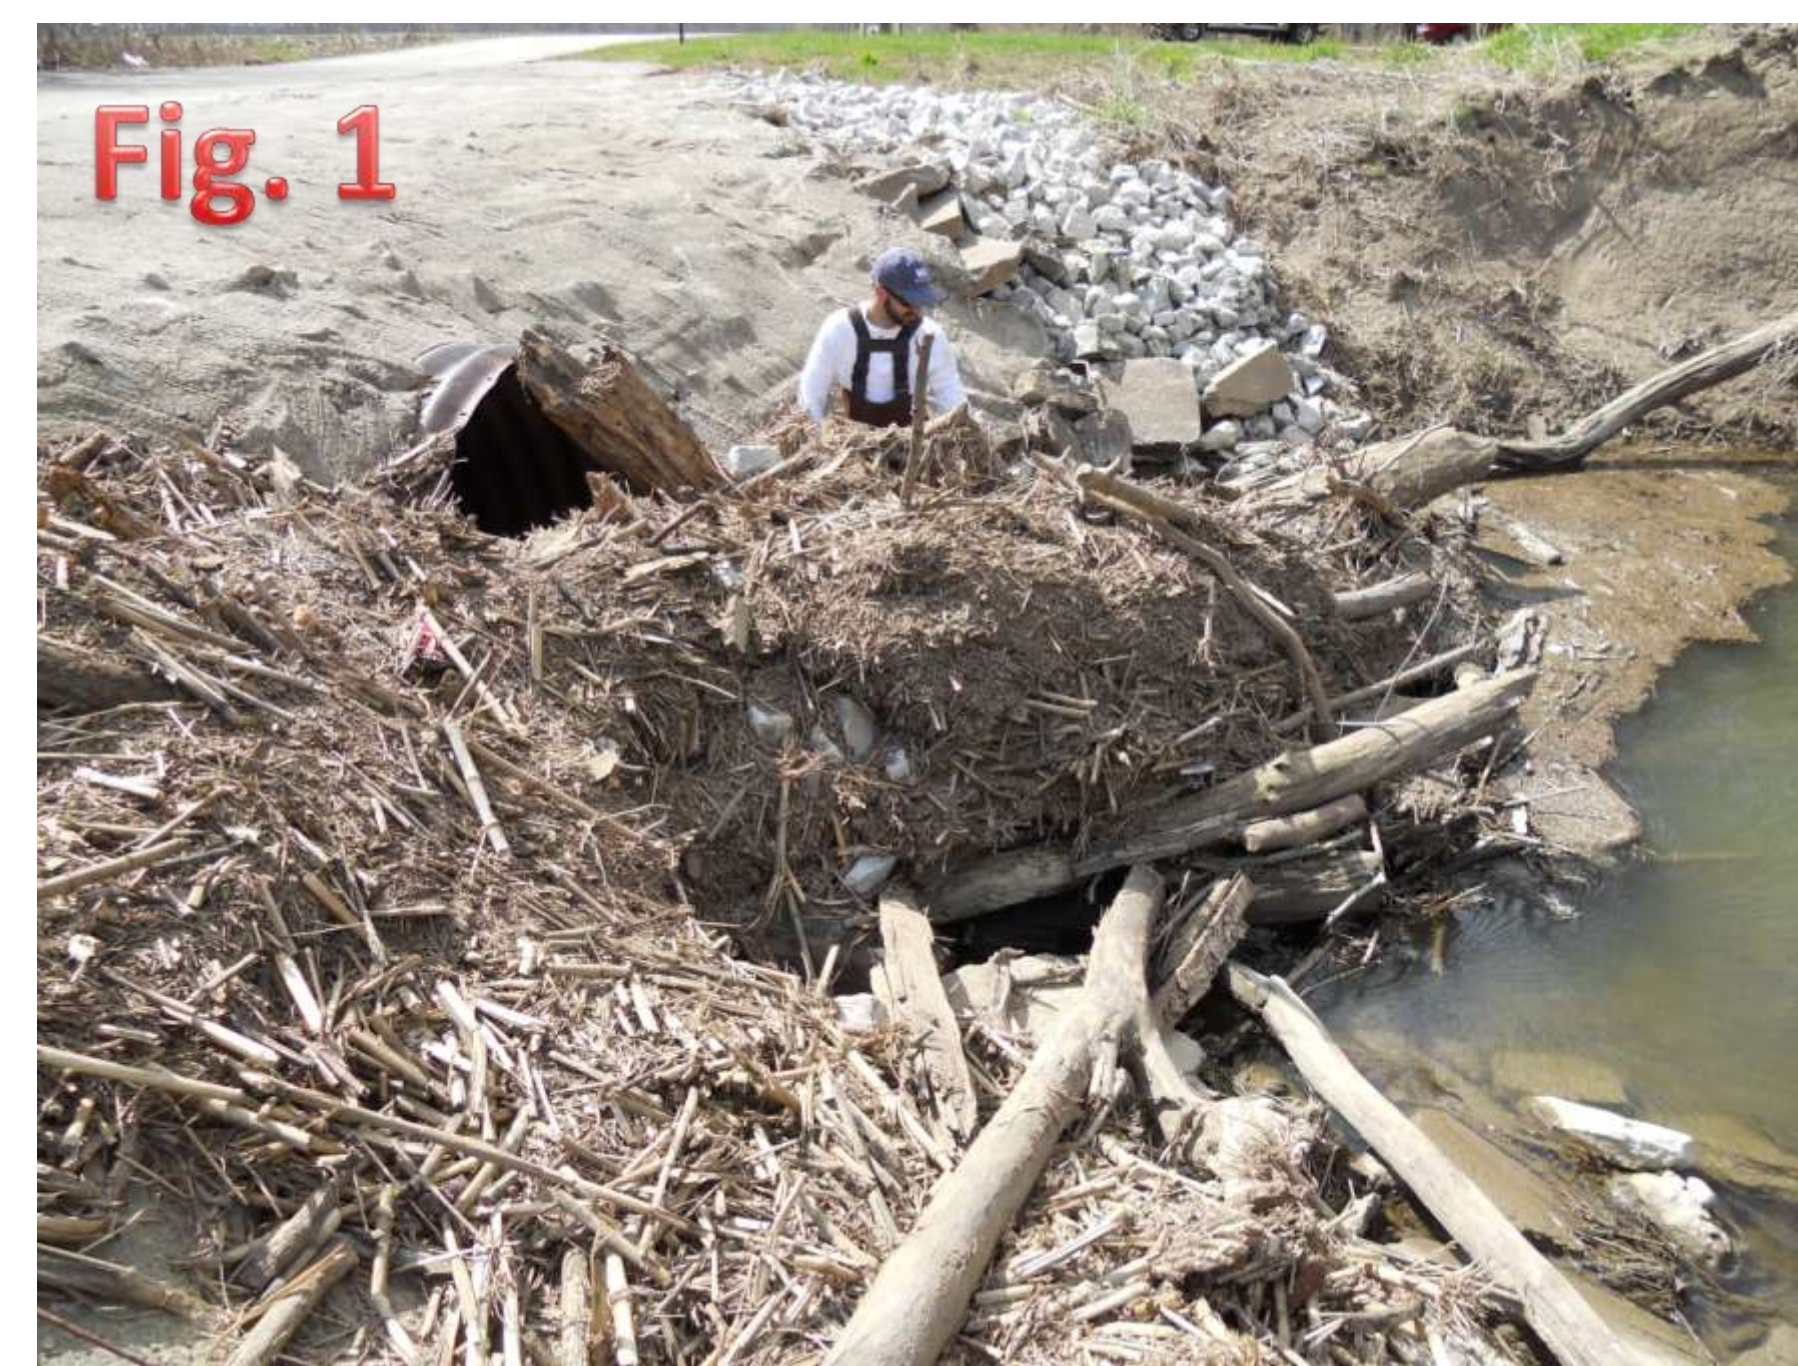
Problem 1:

The culvert was only sized to pass 20% of our calculated flow. This backup caused problems such as scouring, road sink, and infrastructure degradation.

Problem 1: After evaluating our options we chose a CONSPAN arch from CONTECH (Fig. 5). We will be using a bridge with a span of 36’, and a rise of 11’. This will allow us the advantage of having a natural stream bottom suitable for fish passage.

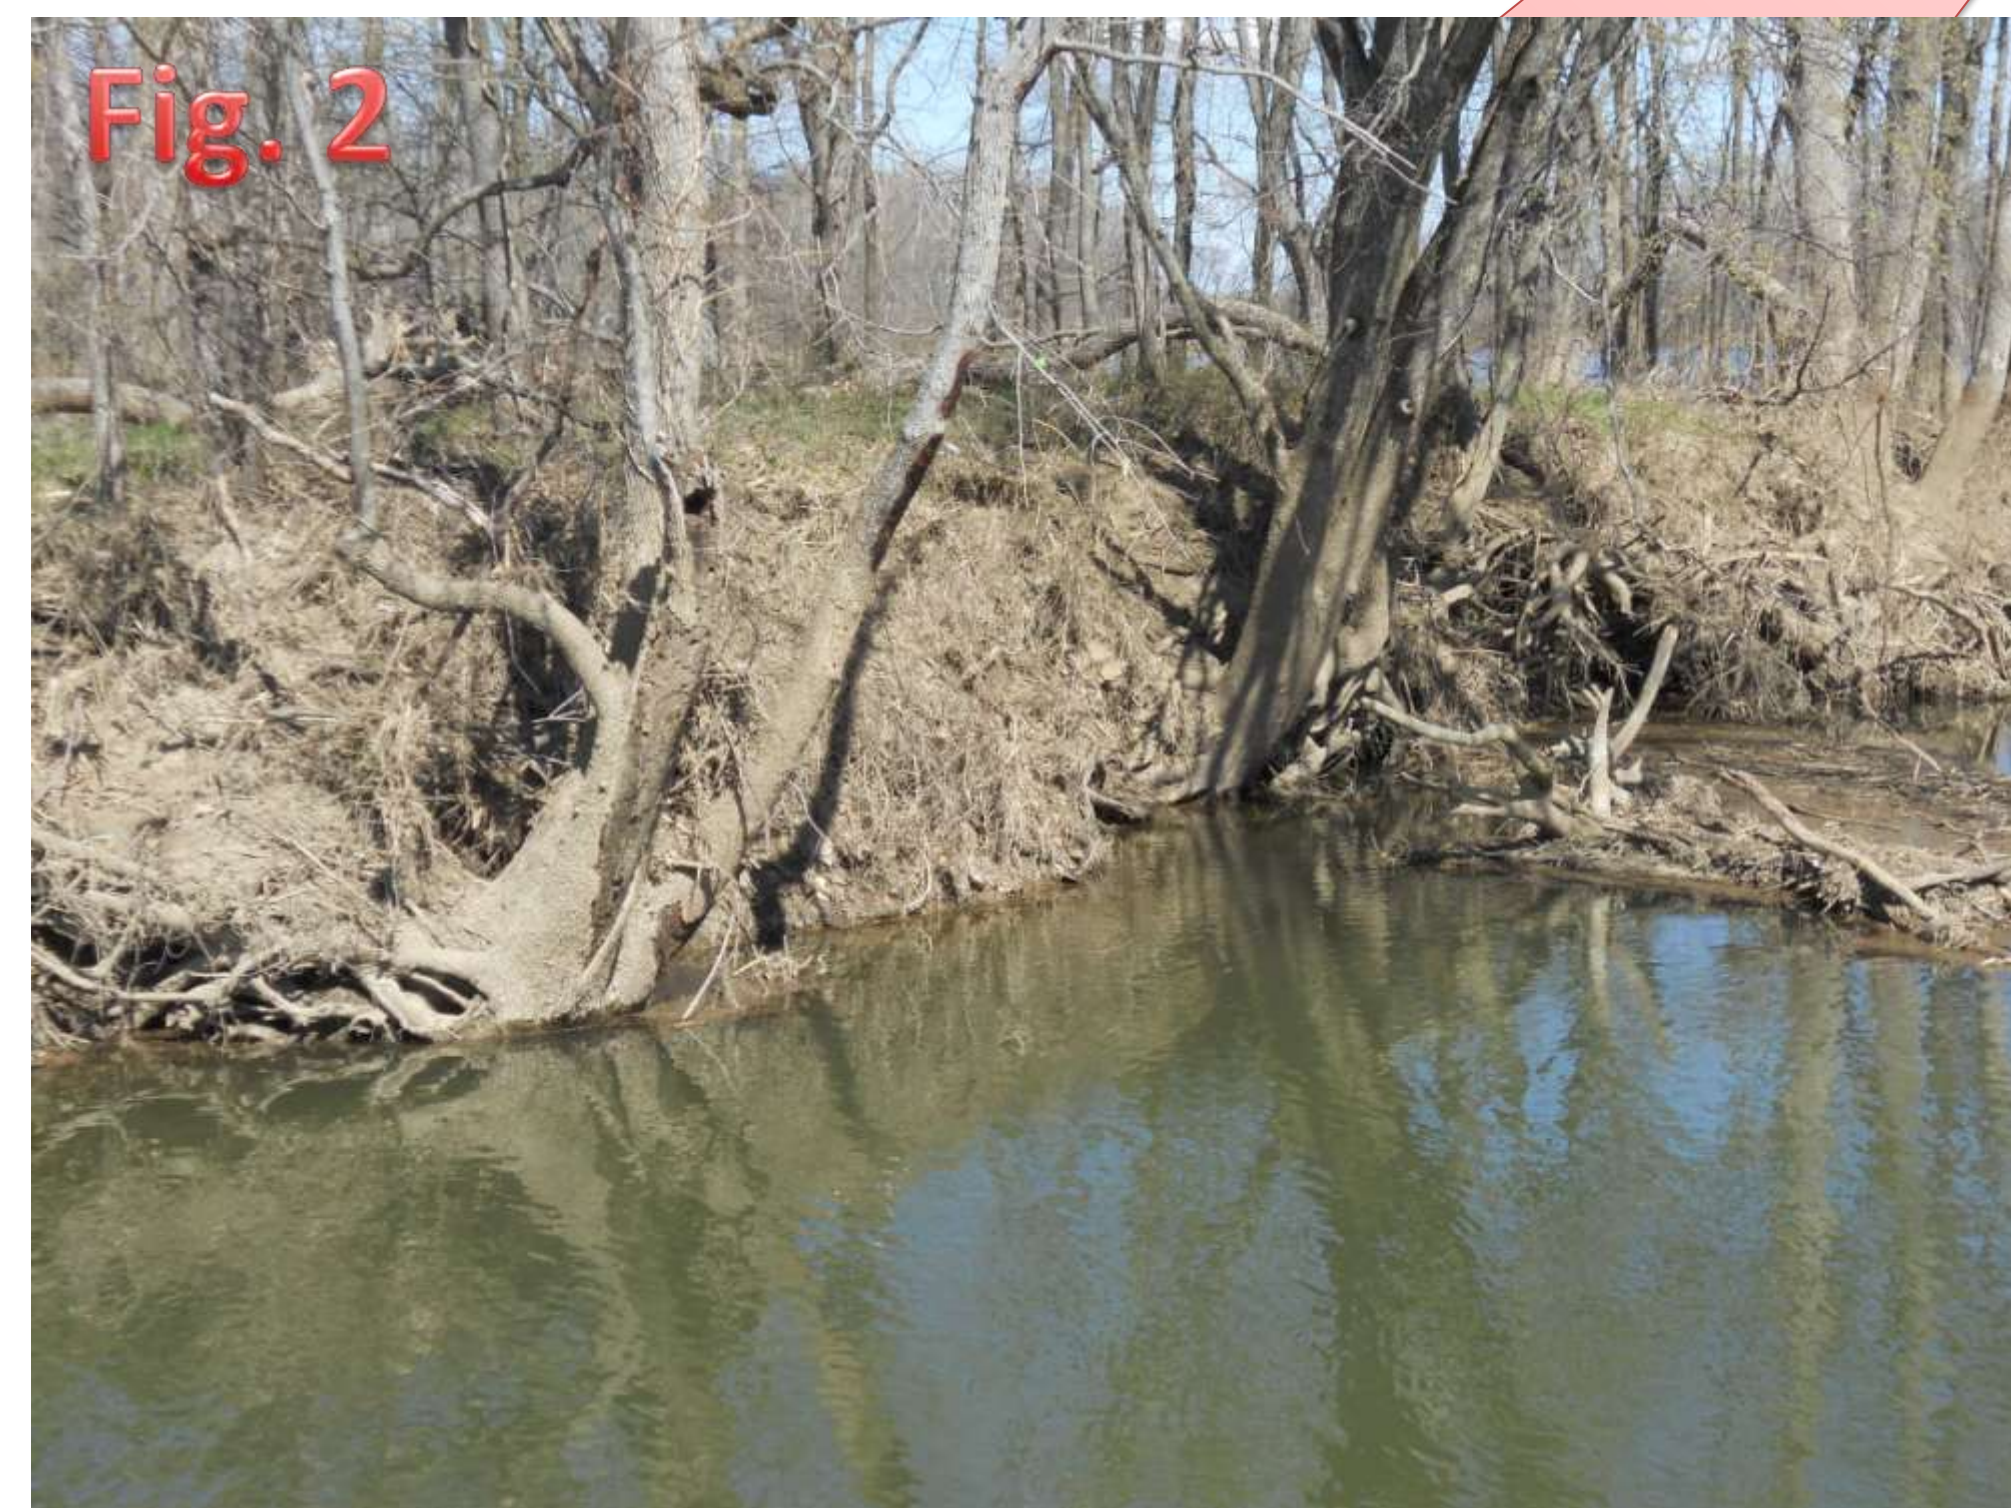
Problem 2:

The lack of bank cover acted in combination with the poor hydraulics of the culvert to cause heavy erosion on the banks of the outlet. Several trees have been undercut by this erosion, and are at risk of falling into the stream and causing blockage to the replacement structure.

To combat erosion and tree undercutting, we will be employing A-Jacks (Fig. 6) and Landlok 300 Turf Reinforcement mats (Fig. 7). The sizing for these products was based on the channel velocity (calculated using a cross-sectional based flow program available through CONTECH) and the shear stress ($\tau = \gamma R S$).

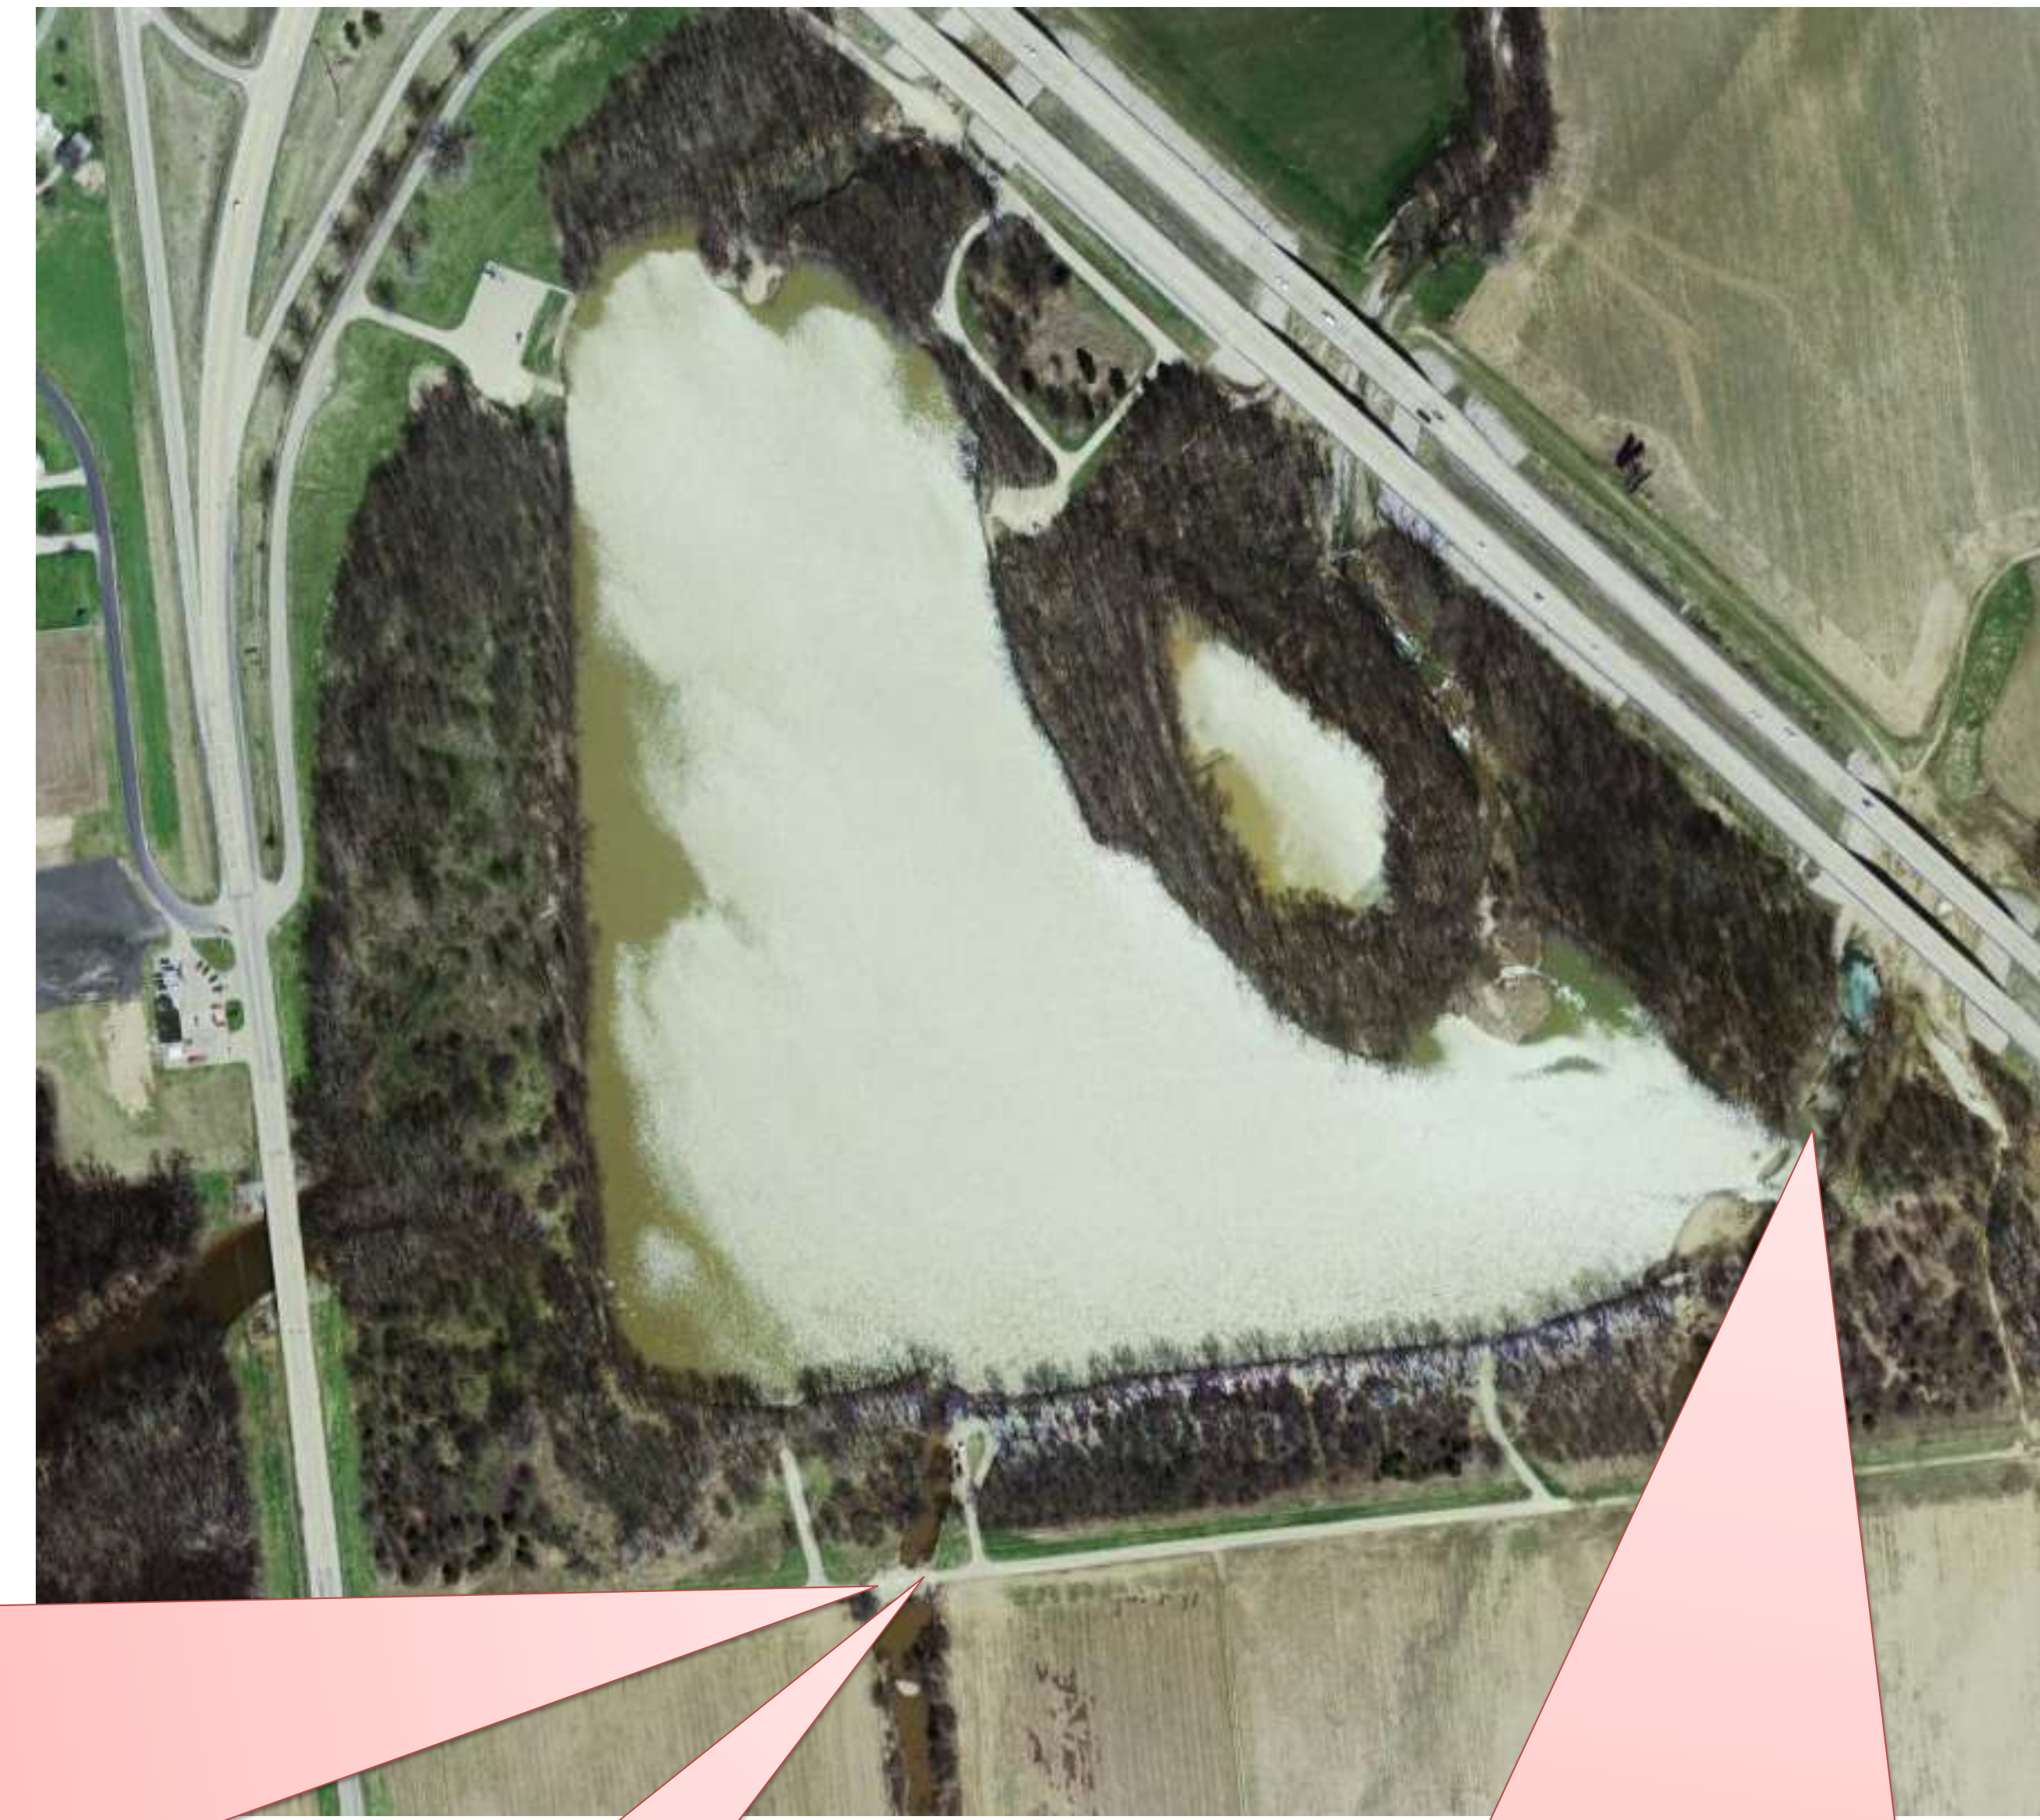
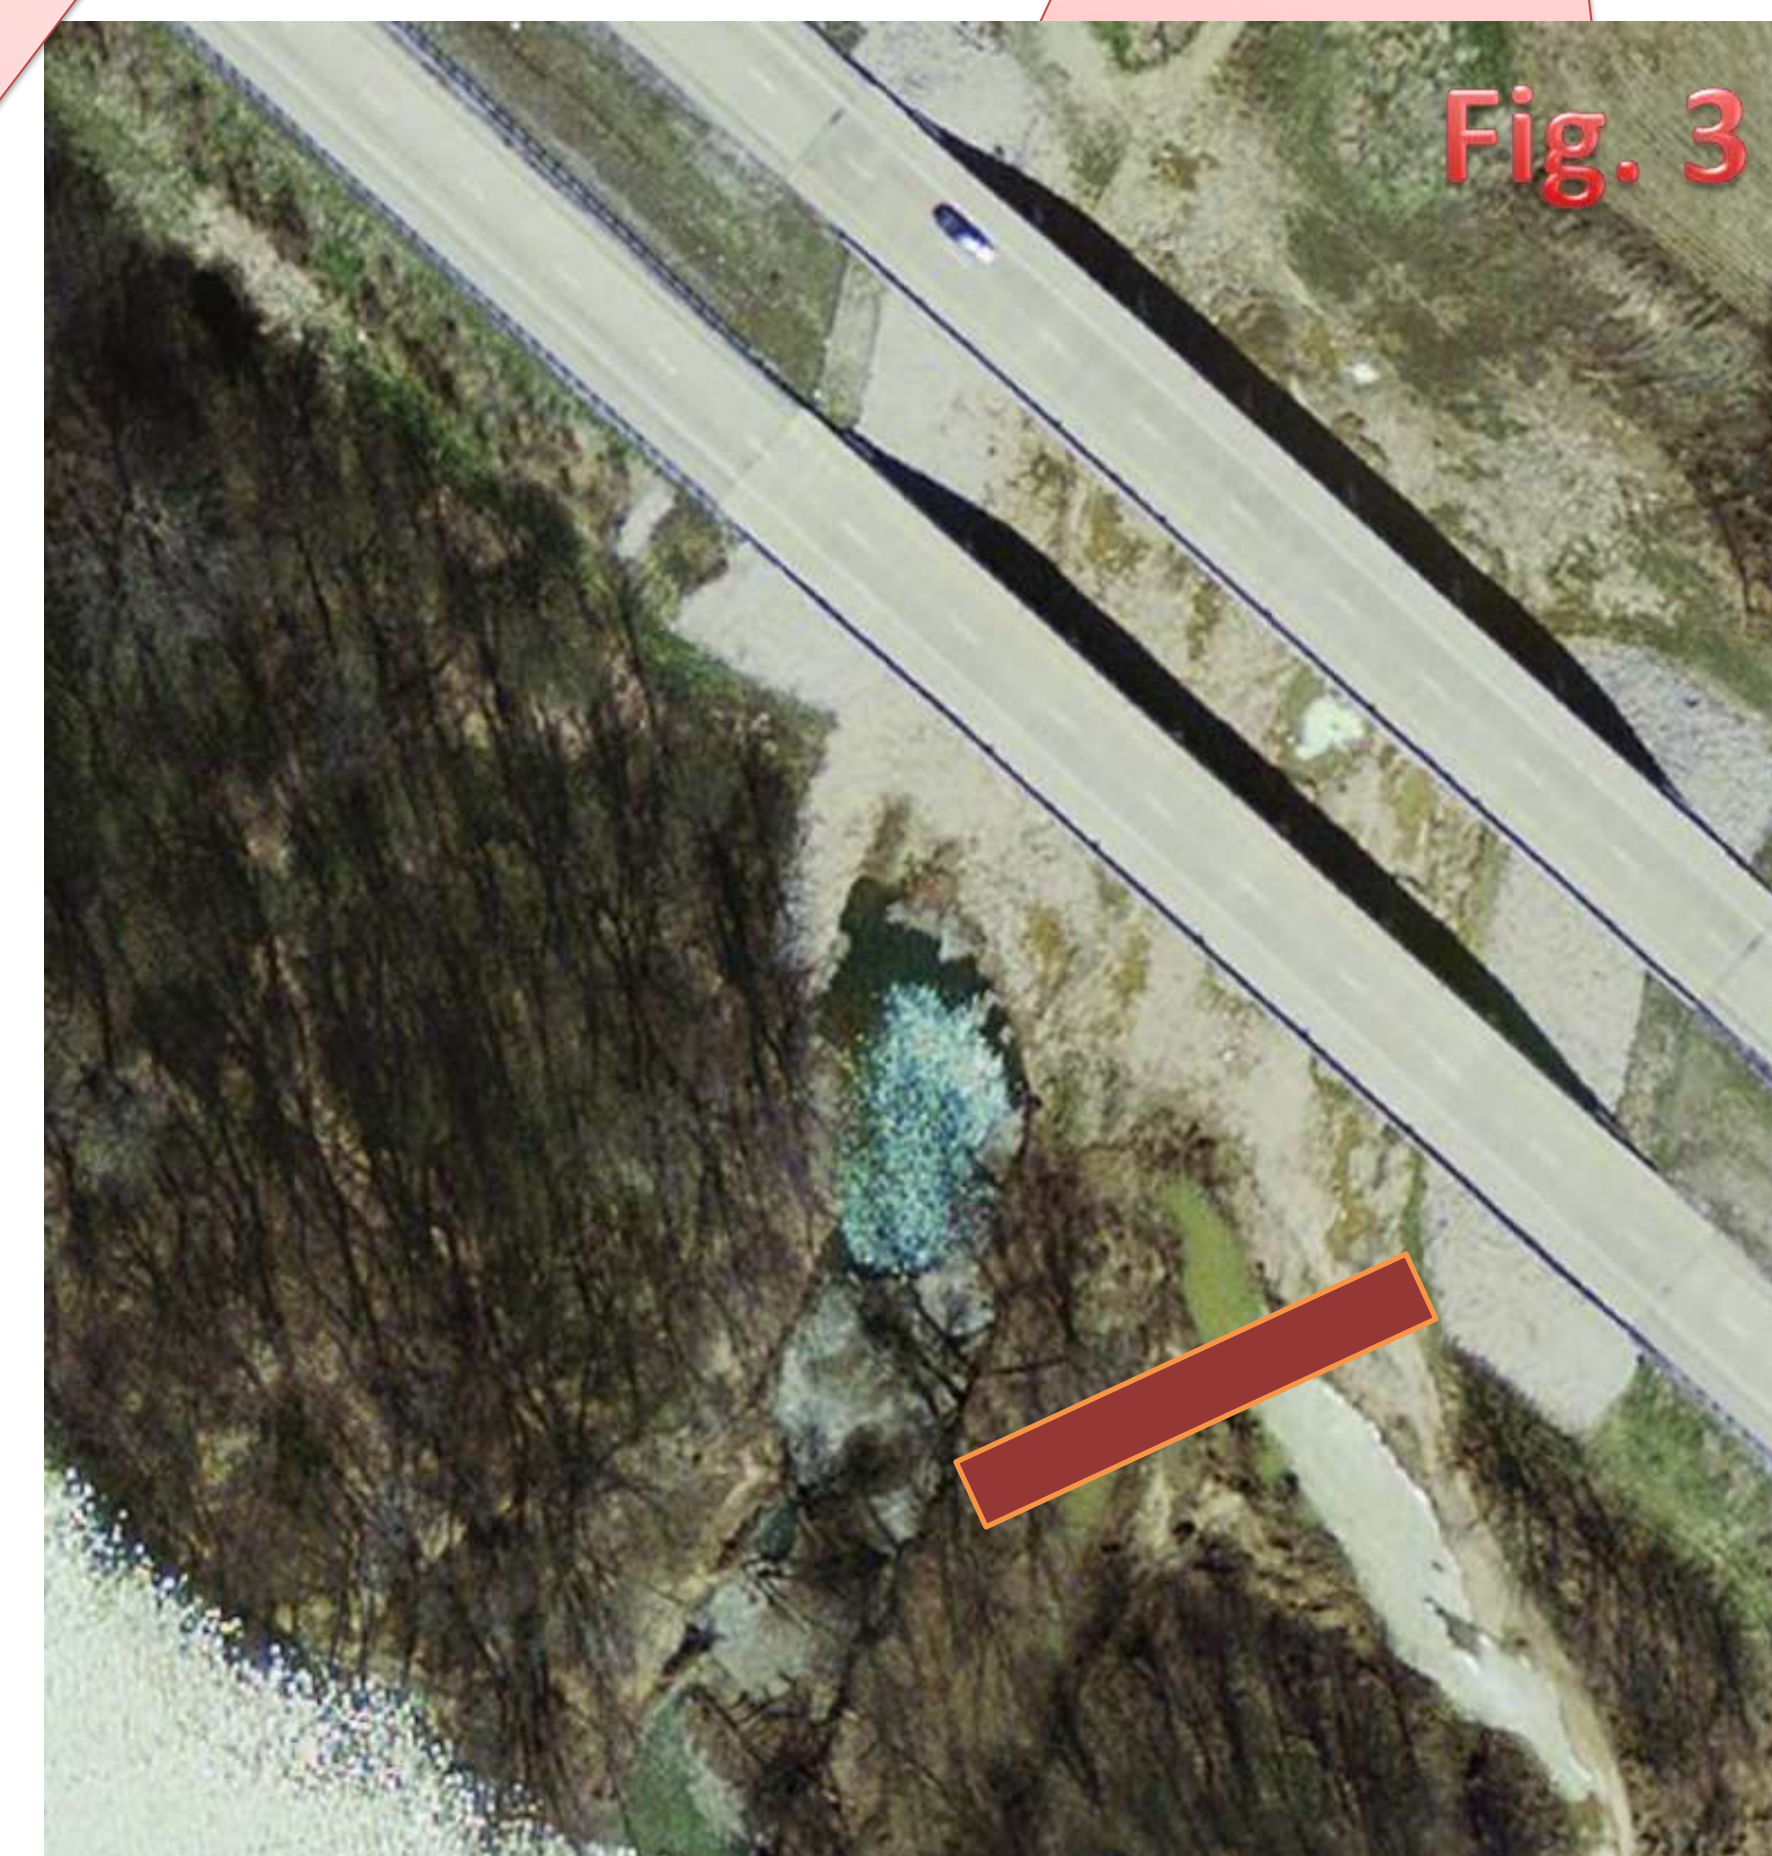
Problem 3:

Near the main inlet (flowing under I-65), water was backing up and forming undesirable channels. As can be seen from picture three, a permanent wet area has formed as a result of this channeling and other erosion can be seen at the ground level.

Alternate flow patterns will be prevented by the use of an earthen dike (shown as from top, Fig. 8). This structure will be built as shown on figure three.
